HISTORIC RESOURCES INVENTORY

1. Common name: None
2. Historic name: None
3. Street or rural address: 1006 S. Belle Avenue  
City Corona Zip 91720 County Riverside
4. Parcel number: 117-252-010
5. Present Owner: Carlos P. Madrigal Address: 1006 S. Belle Ave.  
City Corona Zip 91720 Ownership is: Public \_\_\_\_\_ Private x
6. Present Use: residential Original use: residential

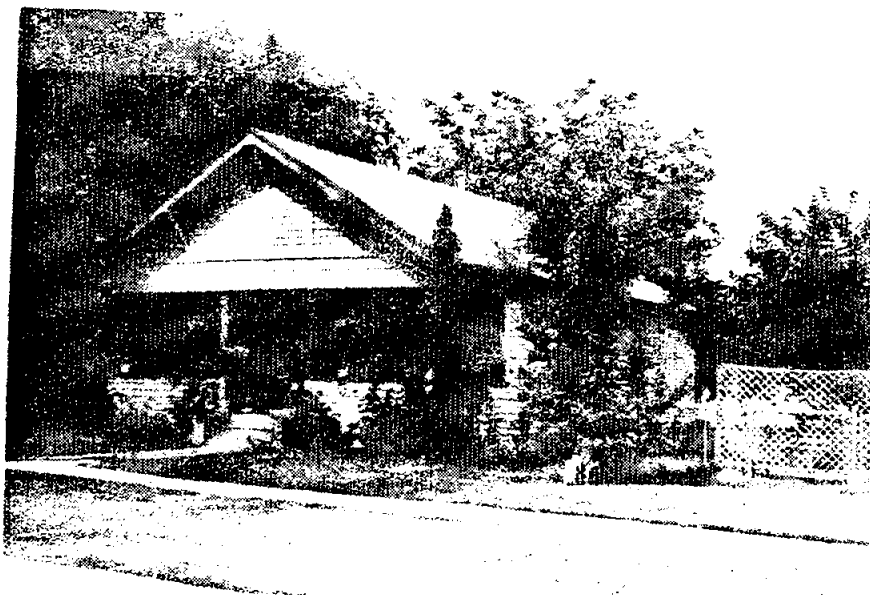
This bungalow at 1006 South Belle Avenue, built on a rectangular basement, has clapboard siding and a moderately pitched front-facing gable roof with three purlins spaced under the eaves. Seven narrow boards extend vertically from below the gable eaves to the fascia board that runs across the top of the balconied front porch which extends the width of the house and is contained beneath the main gable. Four square-turned posts support the porch shelter. The composition tiled roof may have replaced the original.

13. Condition: Excellent \_\_\_\_ Good X Fair \_\_\_\_ Deteriorated \_\_\_\_ No longer in existence \_\_\_\_
14. Alterations: unaltered
15. Surroundings: (Check more than one if necessary) Open land \_\_\_\_ Scattered buildings \_\_\_\_ Densely built-up X  
Residential X Industrial \_\_\_\_ Commercial \_\_\_\_ Other: \_\_\_\_
16. Threats to site: None known \_\_\_\_ Private development \_\_\_\_ Zoning \_\_\_\_ Vandalism \_\_\_\_  
Public Works project \_\_\_\_ Other: \_\_\_\_
17. Is the structure: On its original site? X Moved? \_\_\_\_ Unknown? \_\_\_\_
18. Related features: \_\_\_\_
